BLACK CANYON
REPORT

Subject: Model demonstration of bucket proposed for rehabilitation of Black Canyon Dam Spillway—Boise Project, Idaho

PROPOSED BUCKET
FOR REHABILITATION OF SPILLWAY
BLACK CANYON DAM

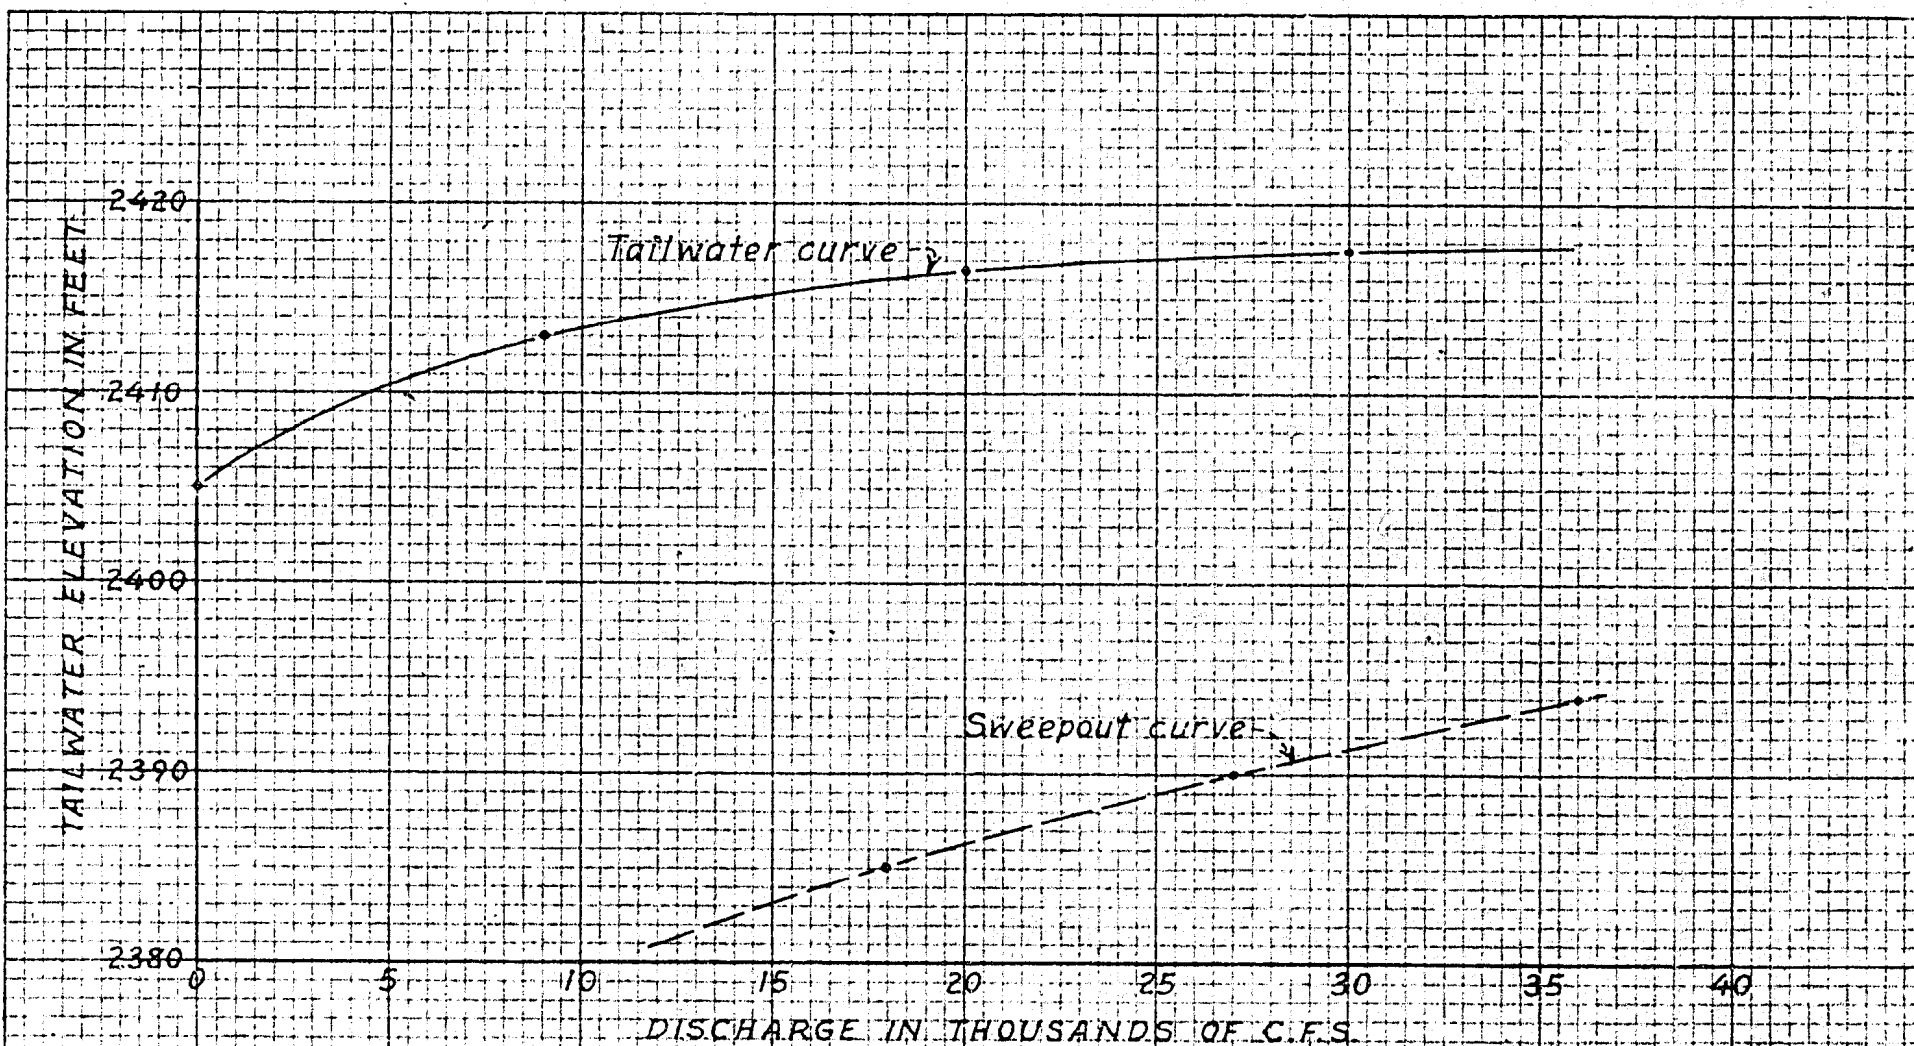
TAILWATER AND SWEEPOUT CURVES
BLACK CANYON DAM

2. Operation of the model spillway was observed by Messrs. Nalder, Hammond, Puls, Schultz, Winter, and Krueger. All expressed the opinion that the operation was satisfactory over the entire range of discharges and tail-water depths. Photographs of the bucket operating at discharges of 9,000, 15,000, 18,000, 24,600, 27,000, 29,300, 33,100, and 36,000 second feet are included as Figures 2 and 3. The estimated tail-water curve used in connection with these tests is included in Figure 4.

3. Sweep out tests were made as a matter of record to determine the tail-water elevation at which roller action in the bucket ceased, or the point at which the jet assumed a free trajectory. This was done for several discharges and the results are also plotted on Figure 4.

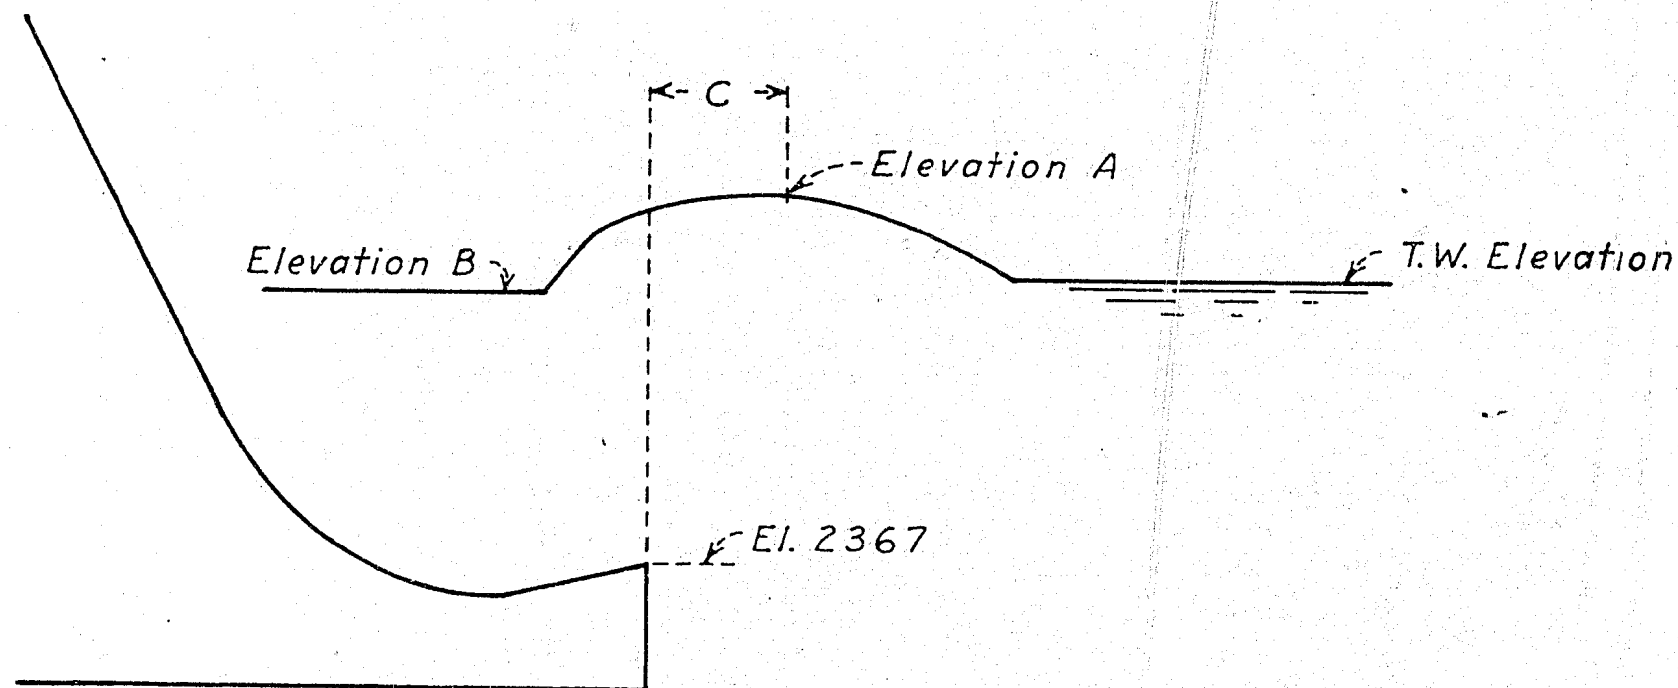
Q IN C.F.S.	T.W. ELEV.	DIST. C FT.	ELEV. A	ELEV. B
36,000	2418.0	44.0	2427.3	2412
33,000	2417.8	43.1	2426.4	2412
27,000	2417.4	39.3	2424.4	2412
18,000	2416.0	32.6	2420.6	2412
9,000	2413.0	21.1	2414.9	2412

POSITION AND HEIGHT OF ROLLER
BLACK CANYON DAM
